**Site Investigation Report
Range, Choccolocco Corridor, Parcel 143Q**

**Fort McClellan
Calhoun County, Alabama**

**Task Order CK10
Contract No. DACA21-96-D-0018
Shaw Project No. 796887**

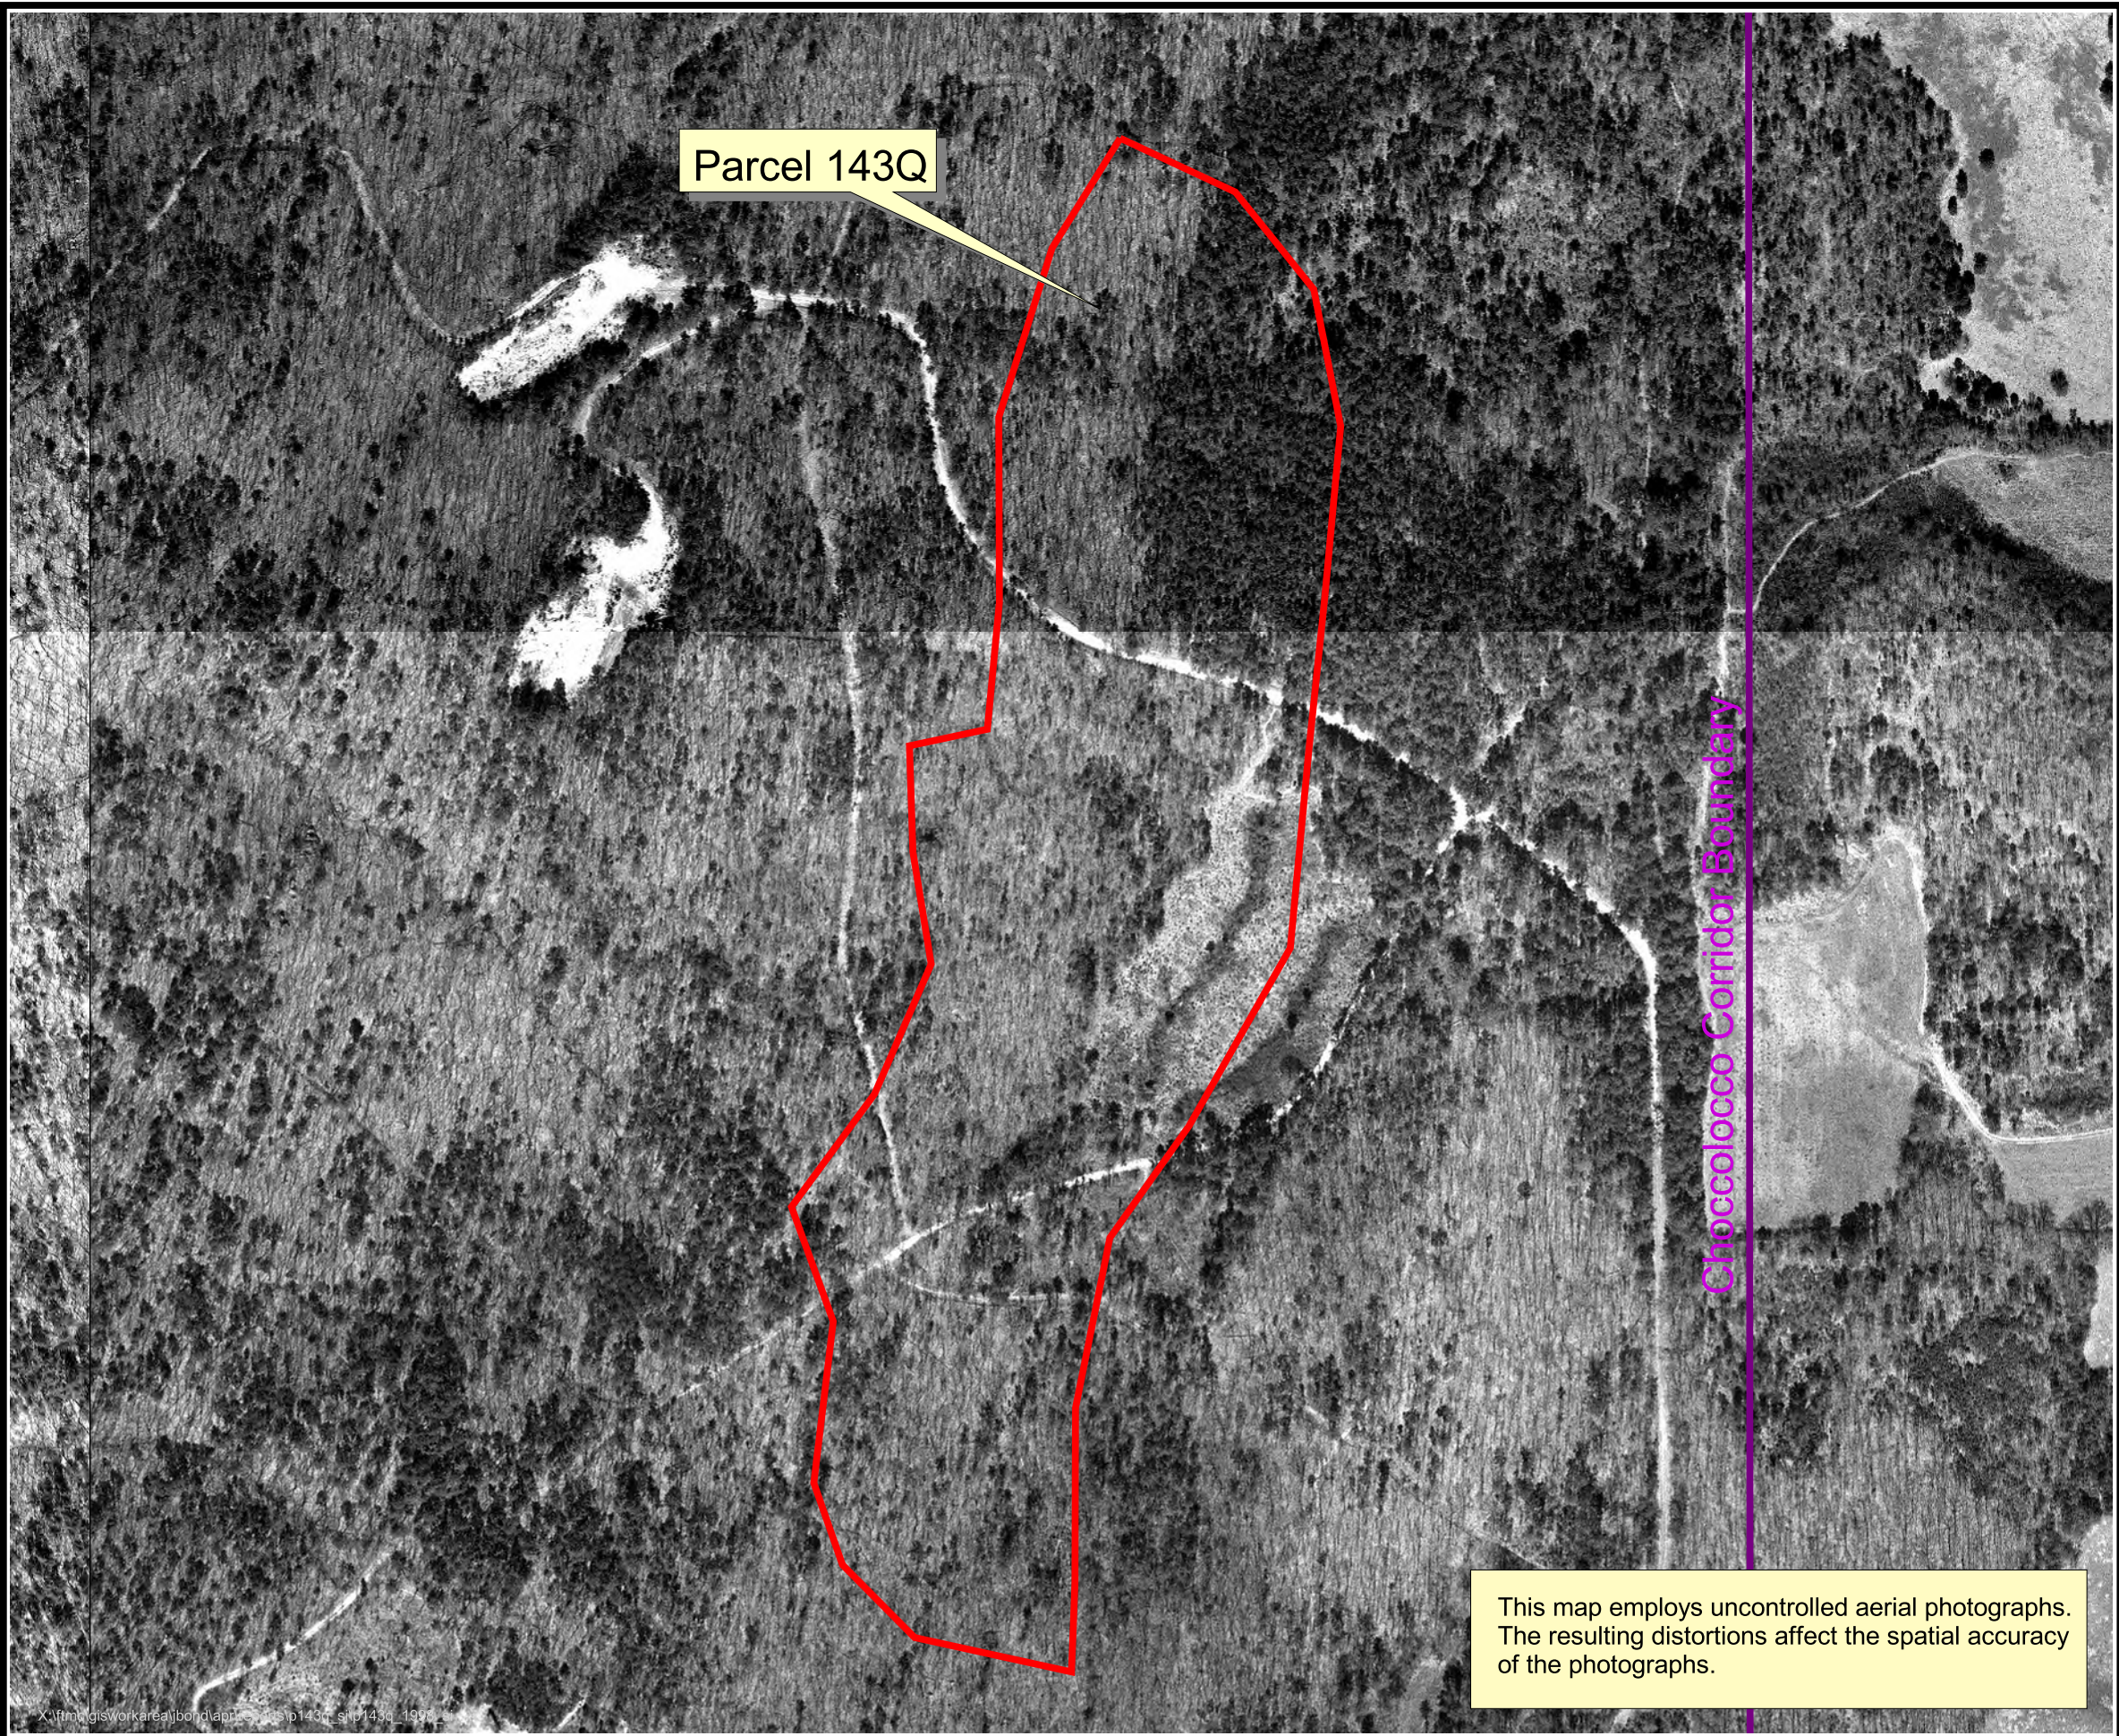
Figure 1-5
1998 Aerial Photograph
Range, Choccolocco Corridor,
Parcel 143Q
Fort McClellan, Alabama

1976, 1982, 1994, and 1998. These aerial photographs are very similar to the 1969 photograph illustrating the increase in tree cover. In the 1994 photograph, an area of several acres has been cleared in the east-central portion of the parcel. The clearing is associated with forestry activity and not related to military activities. The cleared area is also apparent in the 1998 aerial photograph (Figure 1-5).
